Subject: Annual Inspection Report
Jack Edwards Airport

ANNUAL INSPECTION REPORT

**ANNUAL INSPECTION REPORT
JACK EDWARDS AIRPORT
GULF SHORES, ALABAMA**

February 10, 2009

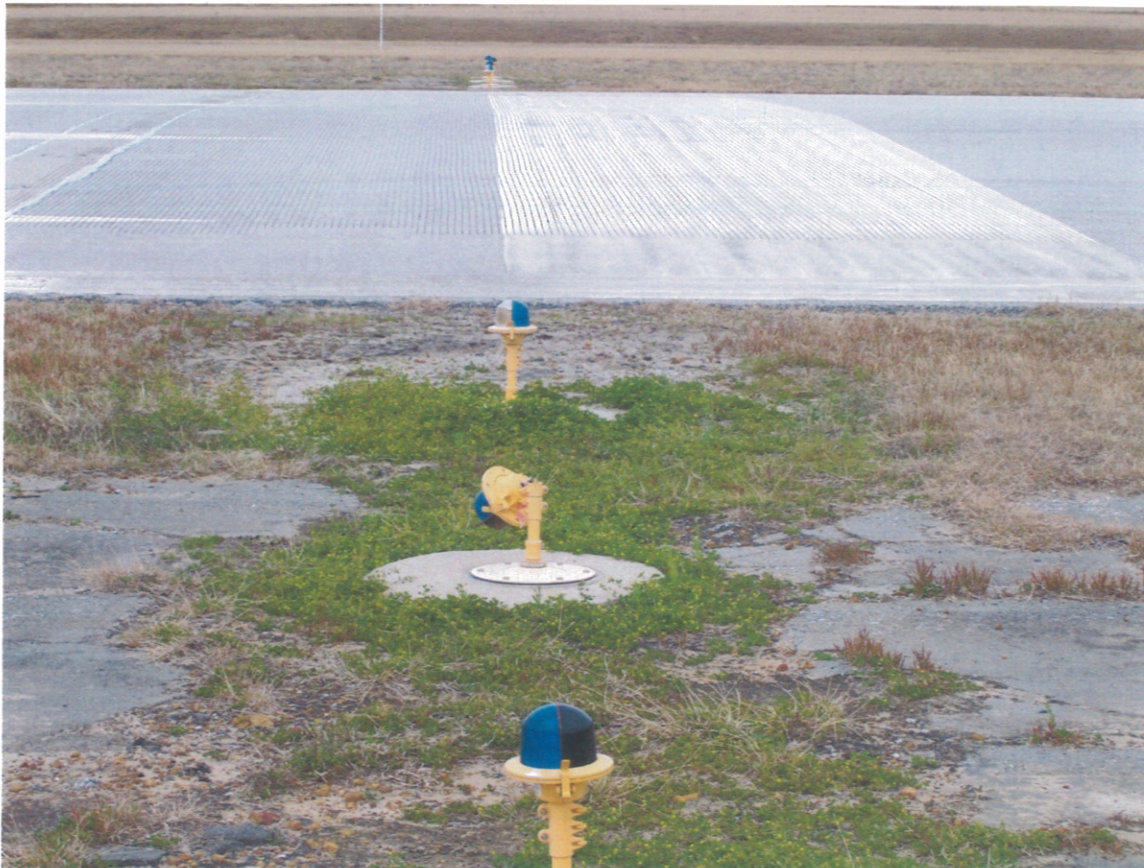
PHOTO 1

- Runway 35 – One threshold light fixture is broken.
- Runway 9 – One threshold light fixture is broken.
- Taxiway Alpha at the 35 intersection – One taxiway fixture is broken.
- Taxiway to hangars – One taxiway fixture is broken.
- Taxiway Foxtrot – Two taxiway fixtures are broken.

Broken threshold fixture Runway 9

- Replace threshold fixtures.
- Replace taxiway fixtures.

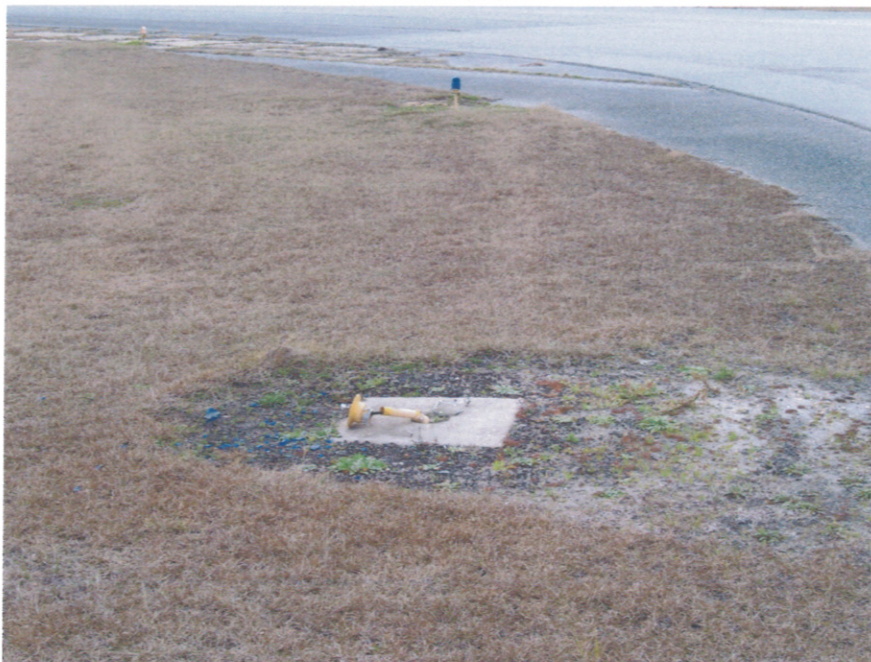
PHOTO 2

Broken taxiway fixture at intersection of Alpha and Runway 35

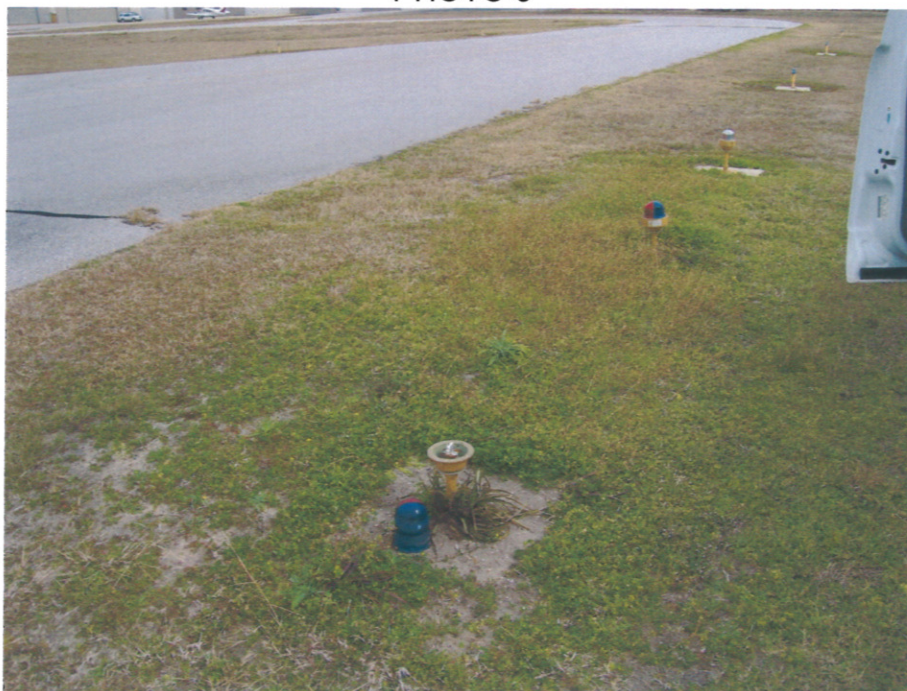
PHOTO 3

Broken threshold light on Runway 35

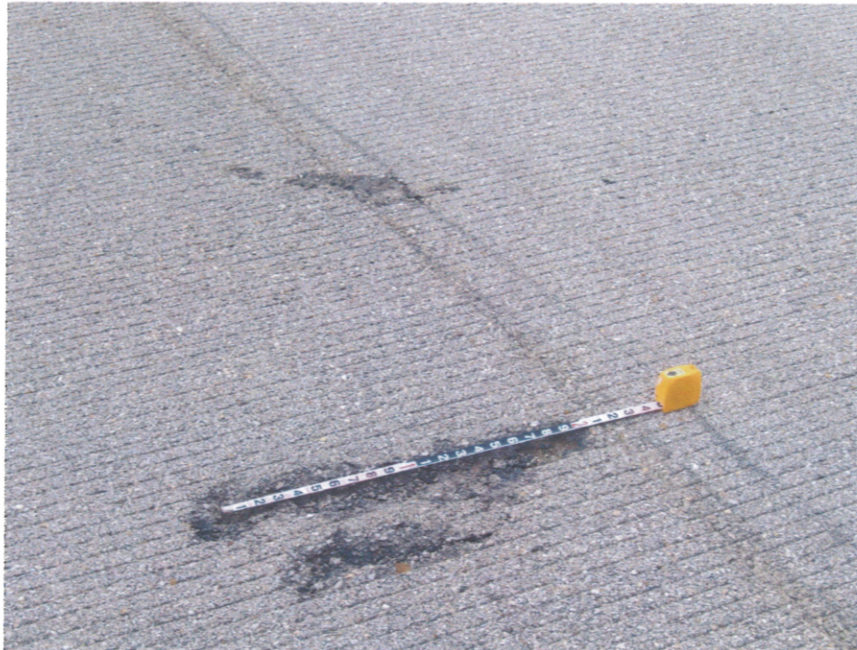
PHOTO 4

- The airport pavement surfaces were inspected and found to be in good condition.
- There is evidence of a lightning strike on Runway 9/27 approximately 1450 feet from the Runway 9 threshold near Alpha 2. The strike resulted in pavement damage where the top 2 inches of asphalt have been removed in three spots. There is one area 2 feet in length and 2 inches in depth.
- Runway 9/27 – There is a section approximately 100 feet in length near Alpha 3 along the south side of the runway that has eroded and left the lip of the pavement at the maximum 3 inch drop.

Damage to pavement from lightning strike

- Repair the runway damage by filling the holes left by the lightning strike. Consult with the airport engineer on the best method.
- Backfill the eroded area along the runway edge.

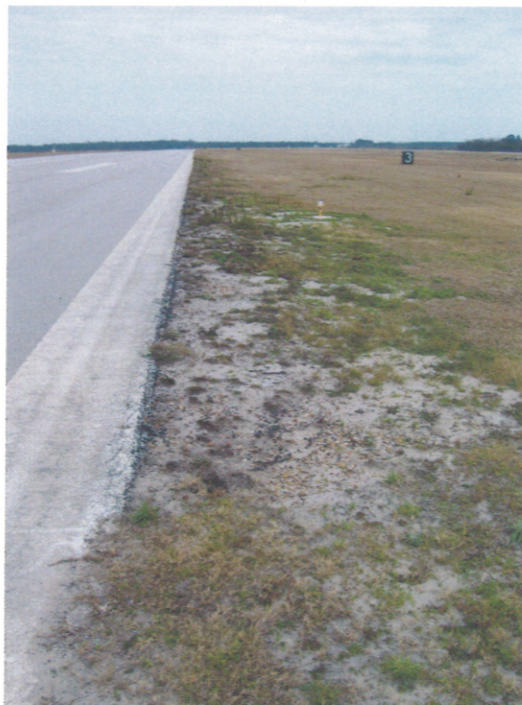
PHOTO 5

Erosion along 100 foot section of Runway 9/27 near Taxiway Alpha 2
